Key to Successful Retrofitting in Bridge Maintenance

Takuyo KONISHI¹, Makoto SETA¹, Jyunichi Tanigishi¹

¹ Japan Bridge Association-Maintenance Comitee, Ginza 2-2-18, Chyuuouku,
Tokyo, jasbc@mxm.mesh.ne.jp

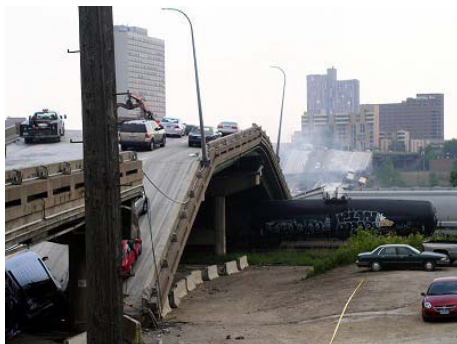
Fig.1 Collapse of Minesota I-35W

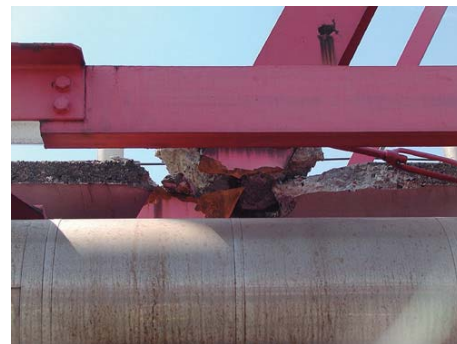
Fig.2 Breaking of a member in Kiso
Riber Bridge i

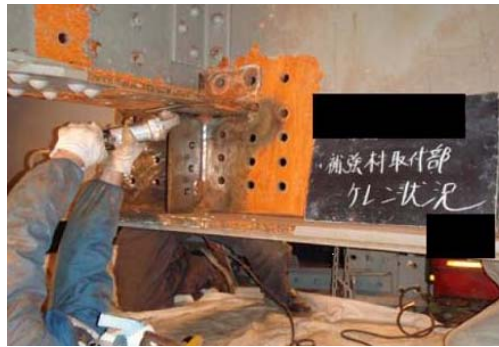
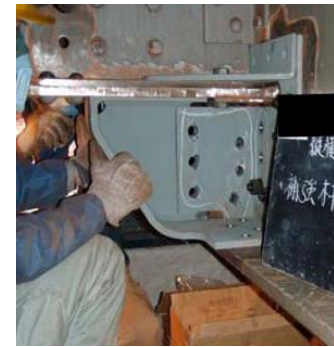
Fig.4(a) Attachment
Sideview

Fig.4(b) Bracket Stiffener

Fig.4(c) Bracket Stiffener

Fatigue cracks were found at the boxing weld of lower web gap plate for the connection between longitudinal girder and cross girder. This fatigue crack is found at the conjunction of longitudinal member and transverse members. Cause of this crack is the existence of end moment at the connection produced by the deflection of longitudinal girder. Attachments are inserted to the gap between lower flange of longitudinal girder and lower flange of cross girder as shown in Fig 4. The attachment is bracket type rib supporting end moment of longitudinal girder.

Problem with this attachment was that the gap between both flanges were not constant and some of them were too small for the attachment and there are no margin for it. Existing structures always have fluctuation of size that is not mentioned in design drawing. They are caused by time dependent inelastic deflection, dead load deflection, fabrication error and so forth. It is preferable to check actual size of space to set beforehand and design new member to fit into the space or allow such margin.

They ground lower flange of existing members to increase the space for attachments first but the construction schedule was delayed due to the grinding works. Then they changed height of attachments smaller and use filler plate to fill a gap.

Flange of the attachment is bent by press machine and full penetration is required for welding. There exists possibility of size error. Adjustment function should have been implemented in the attachment.

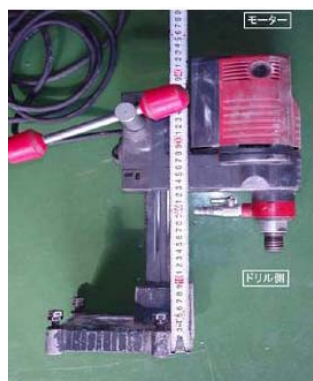
Fig. 5(b) Core drilling
machine

The two box girder bridge with one bearing in each girder was to replace support bearing. For replacement of support bearing, it was necessary to make holes in concrete substructures for setting anchor bolt by using core drilling machine shown in Fig.5b. There was 500 mm clearance below the lower flange and drilling was hard in that clearance because of anchor bolt length and height of the drilling machine.

Original plan was changed in construction step. All the works in box girder are changed to complete under the lower flange of the box girder. Core drill machine is modified from 650 mm height to 450 mm height. Anchor bolts are cut into two peaces and screw type cupla is used to connect two of them. Gather information widely from equipment maker or professional in that field may help to get the right answer.

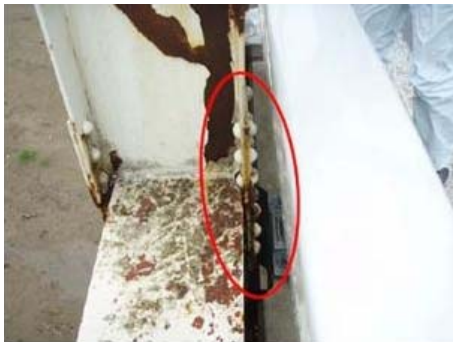
Fig.6(a) Rivet bolt to be replaced

Head of rivet bolt were rusted and partly damaged severely in a bridge and it needed replacement. Replacement of rivet bolts to high tension bolt was planned and ordered to constructor. But it turned out that damaged rivet bolts used in gusset plates located too close to the railing of bridge and there were small clearances between them (Fig.6.) Since the replacements of rivet bolt in such a narrow space are not easy without removing other obstacle structure, such as railing, part of deck, the replacement of rivet was canceled until the other large scale rehabilitation work.

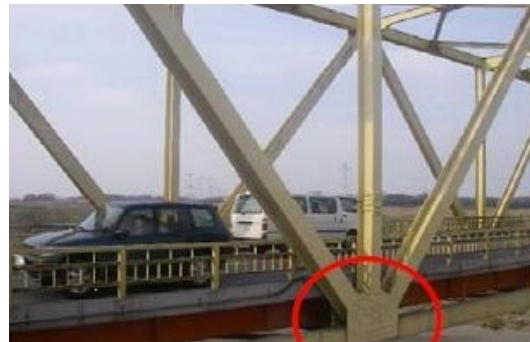
Fig.6(b) Rivet bolt gusset close to the deck

This problem results from the fact that replacement of rivet had never been considered in this bridge from the initial construction. Preparatory study including on-site detail check is inevitable for repair and retrofit. It sometimes happens that a designer makes plan with limited information, such as pictures taken by different purposes, original old drawing, and so force.

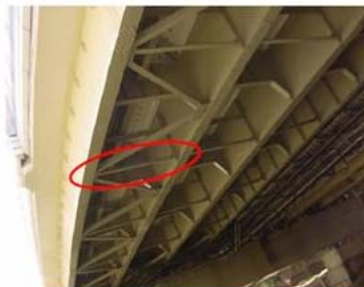
Fig.7(a) Cross bracings of curved girder

Bracket and its supporting beam were to be installed in I girder bridge in order to support a new sign board. To install the supporting cross beam, it was necessary to remove cross bracing between girders near the lower flange (Fig.7(a)). Generally, the cross bracing had been set before the casting of slab concrete and the camber changed after the concrete casting introduced residual force in brace members especially in curved girder. If the force is large, it would become hard to set the removed member back in the right position due to the misalignment of bolt holes. And in extreme case, dead load camber might change.

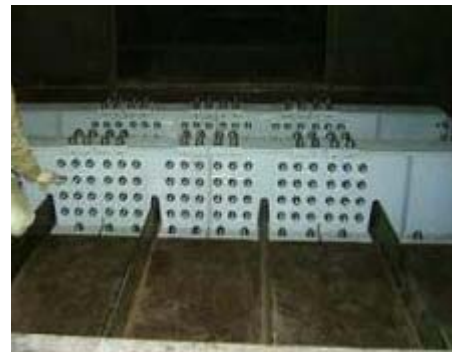
Fig.8(d) Final appearance of supporting beam

After the study about the solution, supporting beams were divided into several peaces and brought into the box from girder end opening as shown in Fig.8(b),(c). In repair and retrofitting works, regardless of how desirable the designs are, there is no use without considering the feasibility of the proposed solution, concerning limitation of space for working, transportation of members, and handling of equipments, such as crane, jack. Attachment members with light weight and small size will often result in better quality and lower cost, especially inside of closed spaces, such as box girder. Lack of consideration with respect to material handling in design phase will result in this kind of unfavorable detail change (Fig.8(d).)

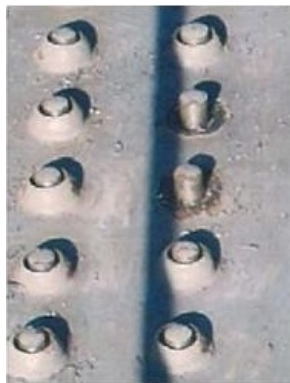
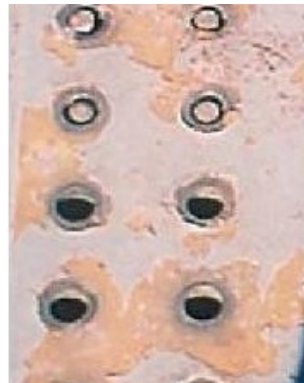
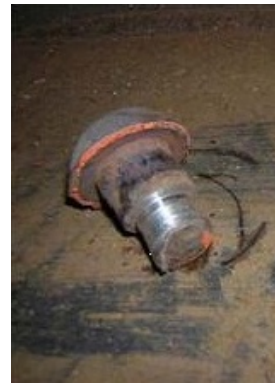
Fig.10 Removal of rivet

(a) Drilled rivet

(b) removal of rivet

(c) removed rivet

(d) Sequence of rivet removal

There are cases when rivet bolt holes of old steel structure are used to attach new members. Removal of rivet is not a special job in retrofitting field these days. Removal sequence of rivet is shown in Fig.10(d). In order to replace old corroded rivet to HT bolt, core drilling machine is used to separate head of rivet at first (Fig.10 (a), Fig.10 (d) step2). Then rivet is removed from plate by pushing axis of rivet (Fig.10(d) step3).

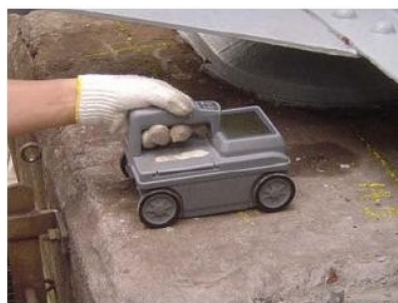
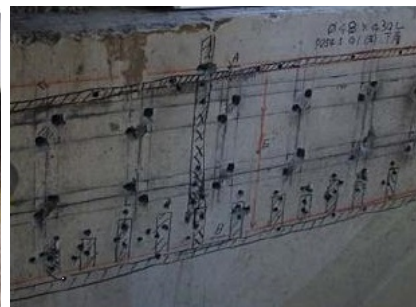
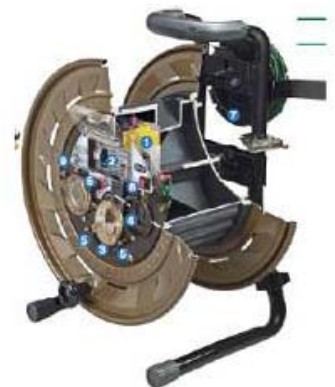
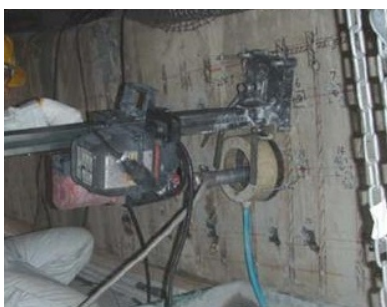
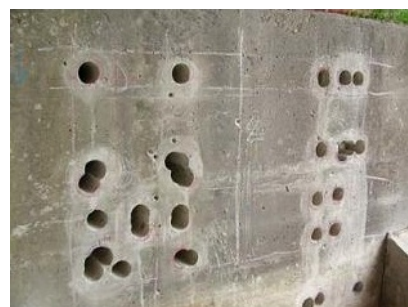
Fig.11 Core drilling for anchor bolt

(a) electromagnetic radiation radar

(b) pilot hole drilling

(e) metal censer code reel

(c) diamond core drilling

(d) after core drilling

Anchor bolts are widely used to attach such steel members as a bracket and a beam to concrete substructure. They are used as a part of anchoring or displacement restriction system to safely protect superstructures against falling downs during large earthquake. Sequence and equipments used for the work are shown in Fig.11. In order not to cut the reinforcement bar in concrete, electromagnetic radiation radar shown in (a) is used. But there is a limitation of sensing depth and minimum interval of bars with this radar and it is not always possible to avoid hitting reinforcement bar only from these information. To avoid cutting of reinforcement bars, pilot hole drilling is executed to assure the location of reinforcement bar (b). Core drilling is generally executed by diamond core drill (c). Metal censer code reel (e), which can stop power supply in case drill bit touches reinforcement bar. Water jet is also used for the same purpose.

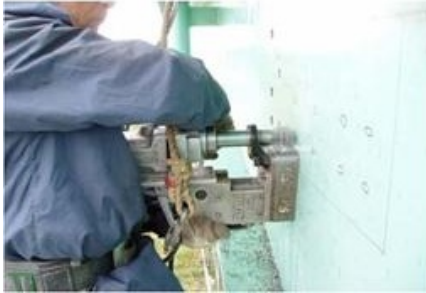
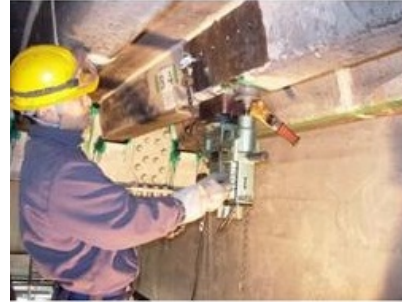
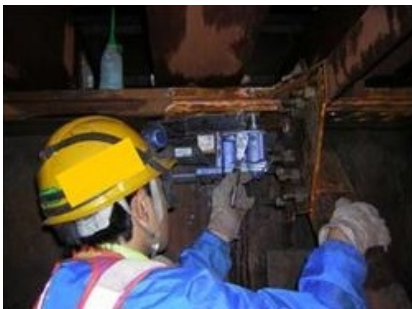
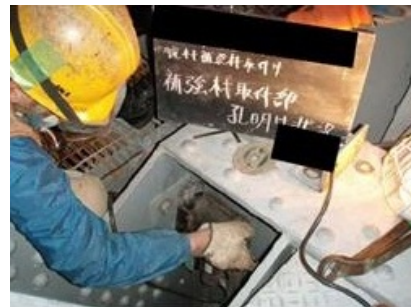
Fig.12 drilling in the field

(a) drilling in girder web

(b) drilling in longitudinal trough rib

(c) drilling in narrow space

(d) drilling in truss node

Handy type drilling machines are available these days and drilling in field becomes easier than before. But drilling in narrow confined space is still hard work and such poor working condition becomes burden for aged field construction workers. Improvement of field drilling equipment is on urgent problem. Fig.12 shows example of drilling in field. (a) is handy type drill machine used for core drilling in girder web. (b) shows replacement of longitudinal trough rib orthotropic steel deck. bridge. (c) is drilling of horizontal stiffener of steel girder to attach a splice member. (d) is drilling from inside of truss chord member.
